## TEST REPORT

<b>Untreated Wastewater</b>
<b>Conventional Parameters / Anions / Metals:</b>	Fulfill Aspirational Limit
<b>MRSL Parameters:</b>	Detected

Factory Name: DAESHIN TEXTILE

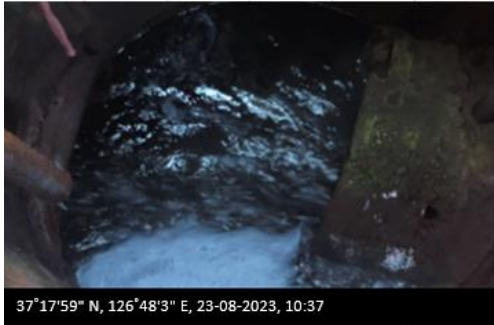
#### SAMPLING LOCATION, CLOSE-UP VIEW

37°17'59" N, 126°48'3" E, 23-08-2023, 10:37

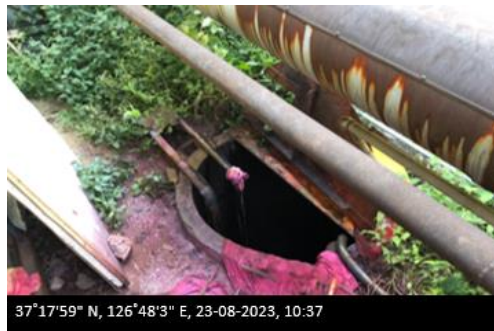
#### SAMPLING LOCATION, FAR VIEW

37°17'59" N, 126°48'3" E, 23-08-2023, 10:37
